BCFerries

ALERT #110

Shoulder injury unrolling new mooring lines

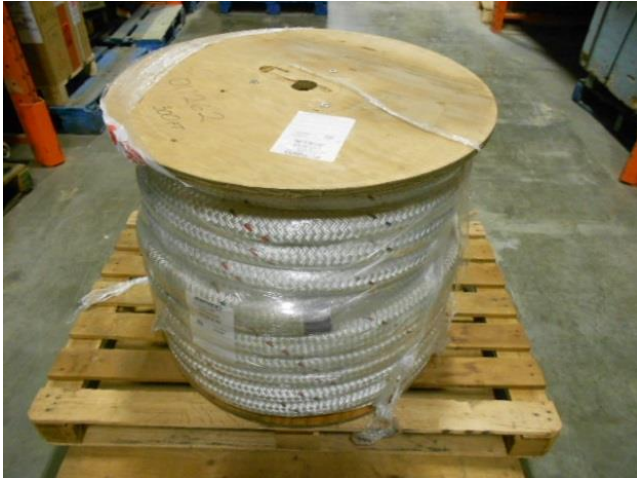
Three Deckhands (including a new hire) were tasked to unspool four new mooring lines and ready them for use on the upper car deck. The spools were tipped from 'on end' to 'on edge' in order to un-roll the line from the spool and avoid the lines becoming kinked. Each mooring line was 300 ft. long with a weight of 136 lb per 100 ft. for a total of approx. 450 lb. including the wooden spool. The work activity resulted in the new hire Deckhand sustaining a shoulder injury.

- All three Deckhands worked together to tip the spools.
- All had proper footwear, were wearing gloves, and were well rested.
- The total weight of the spool was not known at the time of commencing the work.
- Tipping the spool required each Deckhand to lift approximately 112 lb. (if load shared equally) with the remaining 112 lb. taken by the deck as the spool was lifted.
- Unspooling lines is not a common task and pre-planning discussions did not occur.
- Crew members experienced in the task were not consulted prior to implementation.

- Prior to assigning non-routine work, supervisors should meet with employees to discuss the work to be done and identify any hazards, including risk of injury to crew.
- Engage supervisors and fellow crew members who may have had similar experience with this type of work.
- Machinery or lifting gear should be considered.
- Using a crane or chain block would have significantly reduced the risk of injury. If a mechanical advantage is not available, additional crew should be assigned to the task.
- Time constraints should never be an issue when dealing with manual handling of awkward and heavy objects. Always allot enough time and personnel to perform the work safely.
