# **CFerries Divisional Inquiry** DI-QCUM-10239

Incident Name:	Rescue Boat Fall During Man Overboard Drill
Worksite:	Queen of Cumberland
Location:	Swartz Bay Berth #4
Incident Date:	April 18, 2018
iSail Number:	226,156
IAR Number:	IAR-QCUM-4630

On 18 April 2018 during rescue boat drills aboard the *Queen of Cumberland* (QCUM), the davit's wire rope failed and the boat fell to the water with two employees onboard. British Columbia Ferry Services (BCFS) convened a Divisional Inquiry to investigate.

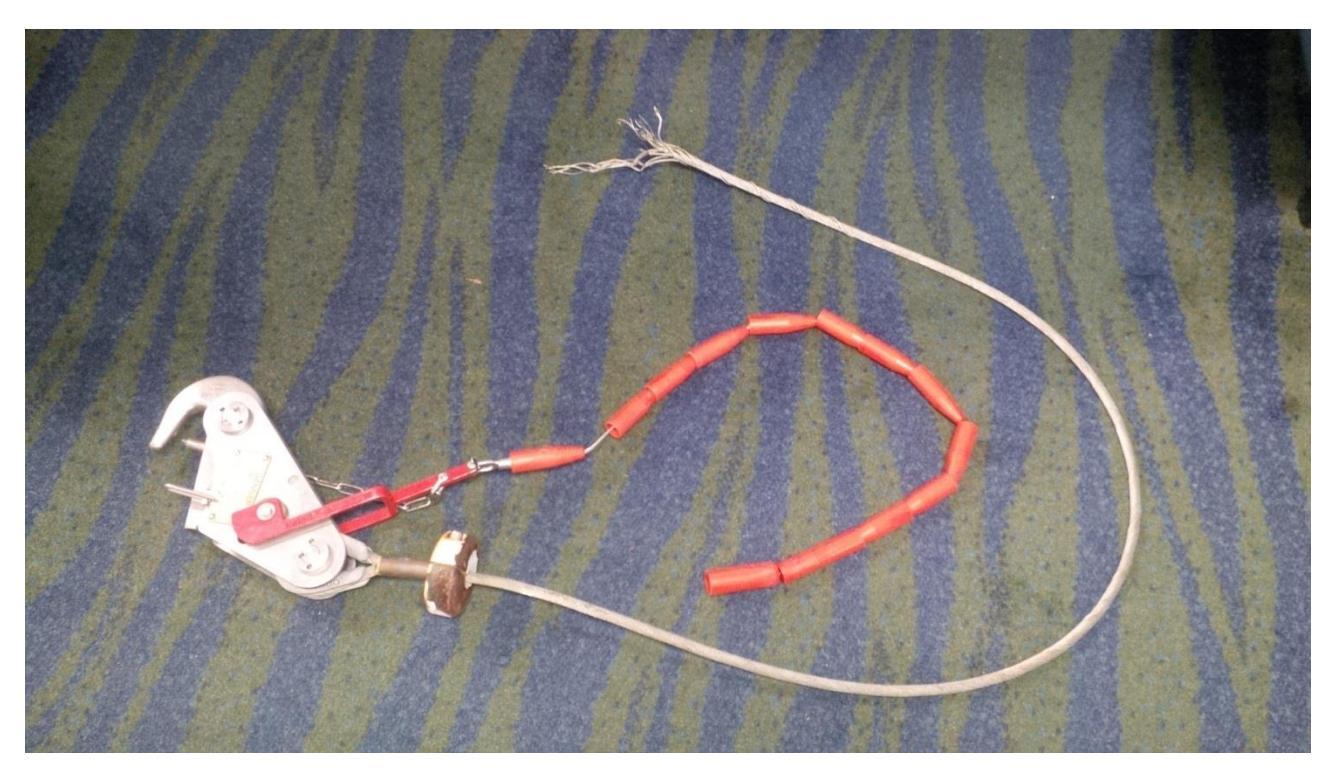
Figure 3 – QCUM parted davit wire rope (with hook assembly)

Upon immediate examination of the equipment, it was found that the davit falls wire rope had parted approximately 1.5 m from the hook end (Figure 4).

- The wire rope was parted approximately 1.5 m from the release hook thimble end.
- There were several exterior wire strands broken and an apparent flattening of the wire rope approximately 0.5 m before the break.
- Microscopic examination of the wire rope artifacts by Acuren (WorkSafeBC contracted Professional Engineering firm) at the region of the parted strands revealed fracture due to crushing of individual wires (Figure 28).
- No corrosion, fatigue or wear was determined as possible causes of the failure.
- Sufficient lubrication between wires was evident.

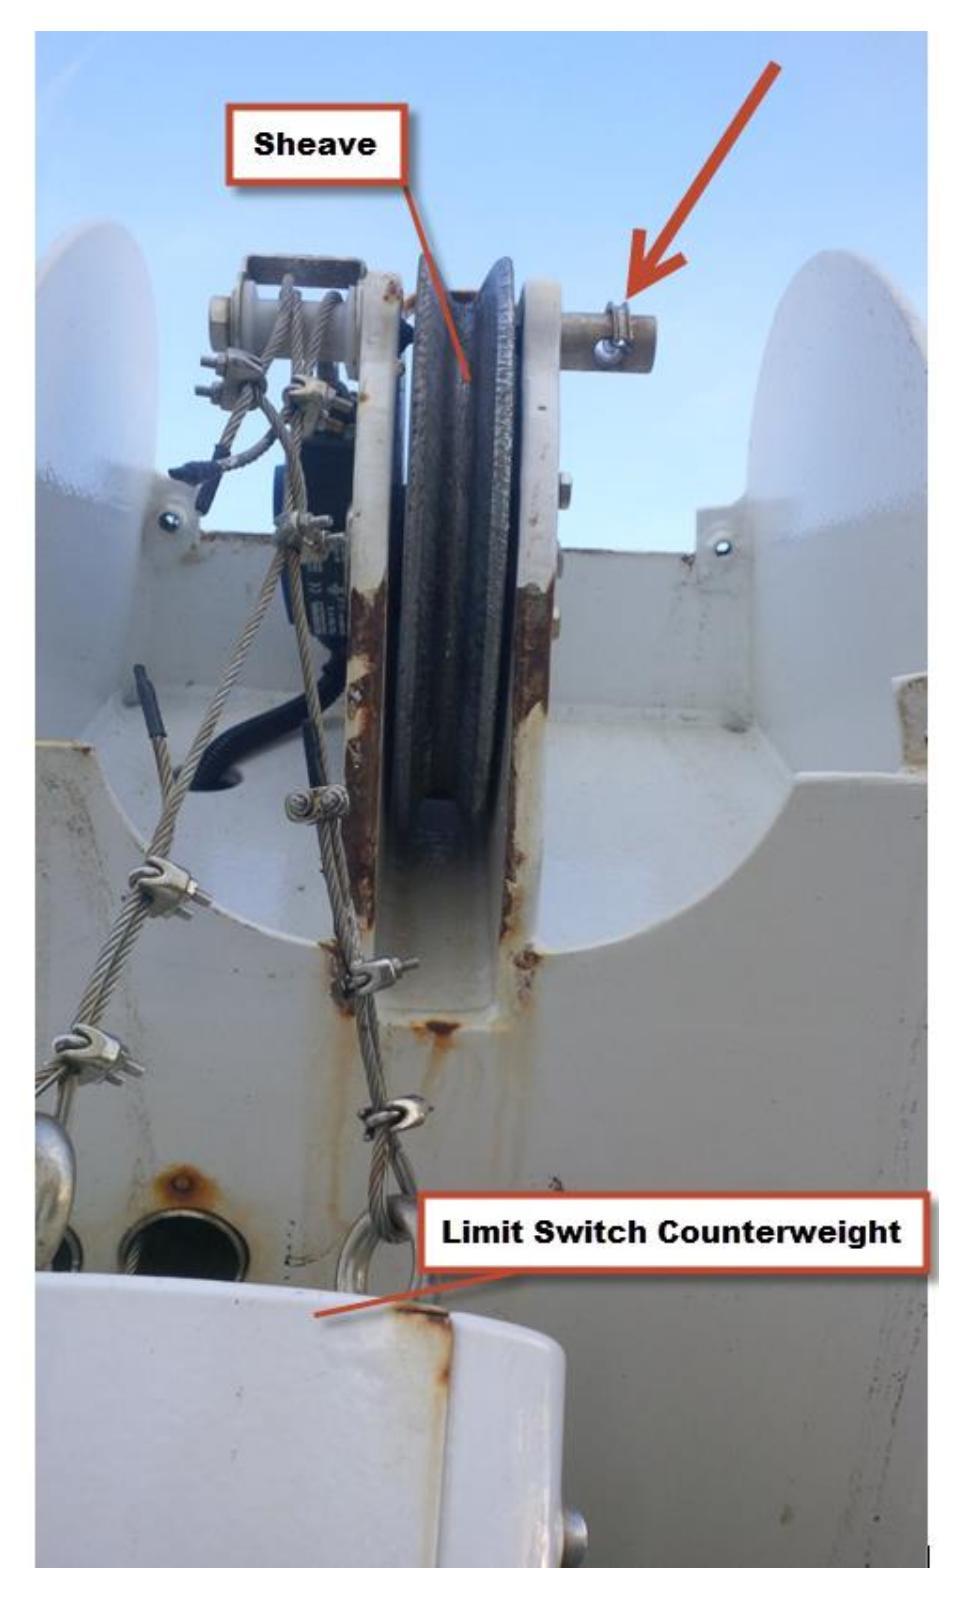
Although the limit switch counterweight is not specifically designed (or specified) by the OEM to act as a wire rope falls angle limiting safety device, it was reported to have acted this way prior to the OEM technician modification in June 2016 (Figure 5 and Section 2.4 – Safety Deficiencies and Reporting).<sup>59</sup>

*Unsafe Act:* The OEM technician modified the limit switch counterweight outside of OEM specifications.

**Figure 4** – Image shows QCUM limit switch counterweight (cable) modification. Arrow indicates where cable *should* be connected to allow limit switch to hang directly underneath sheave (i.e. 1 cable on either side of sheave).

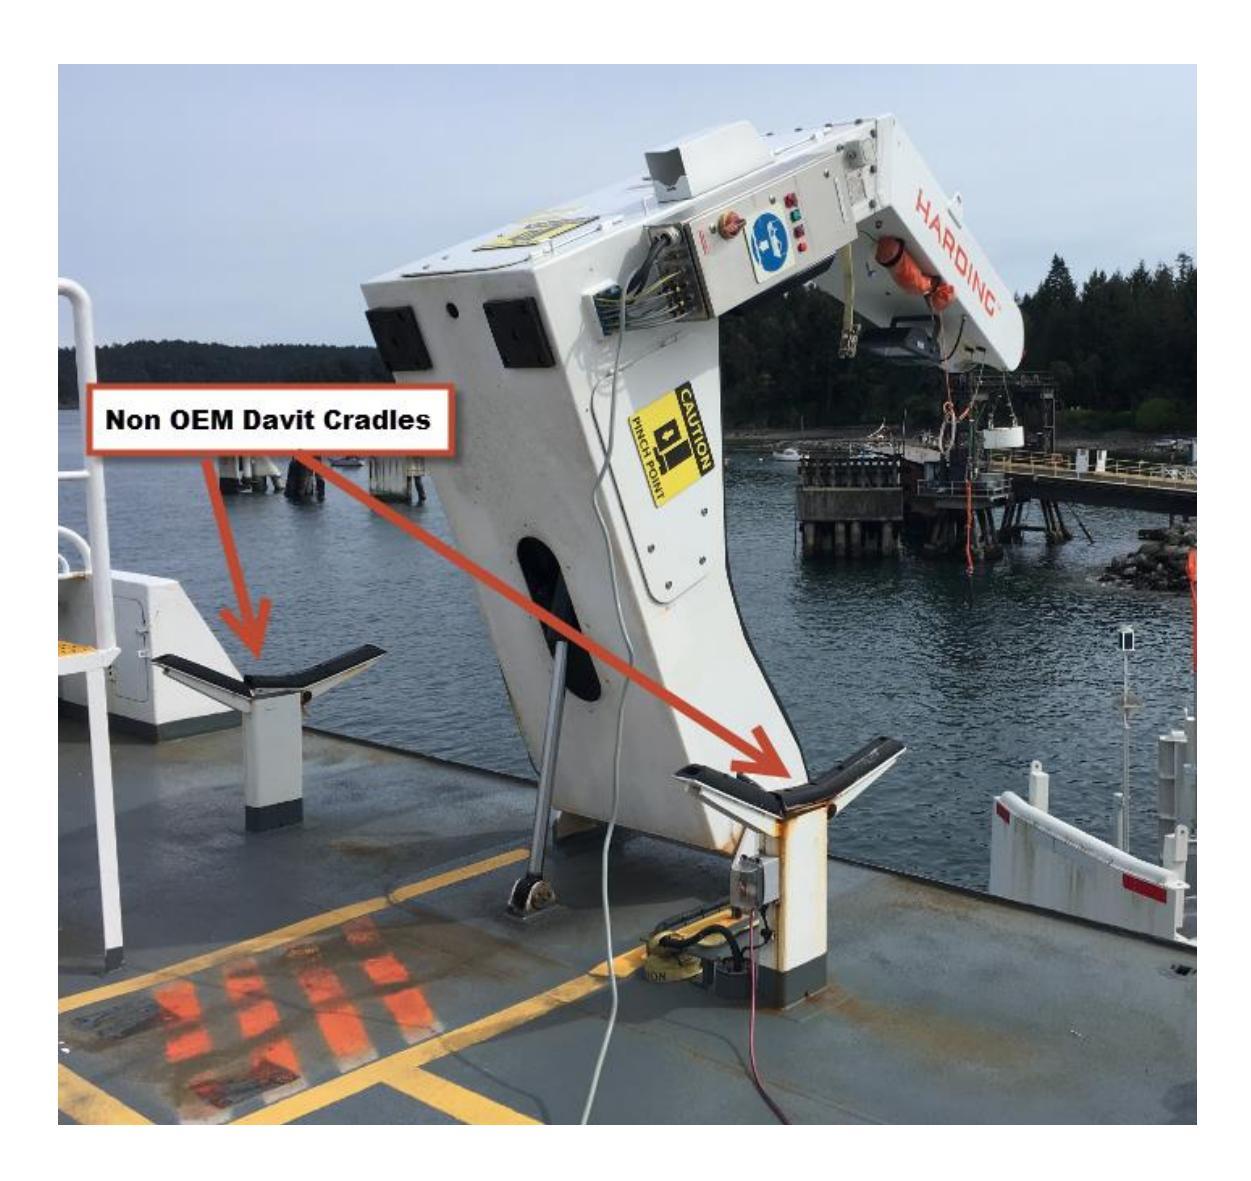
Figure 6 – QCUM davit installation with non-OEM davit cradles (davit is luffed out)

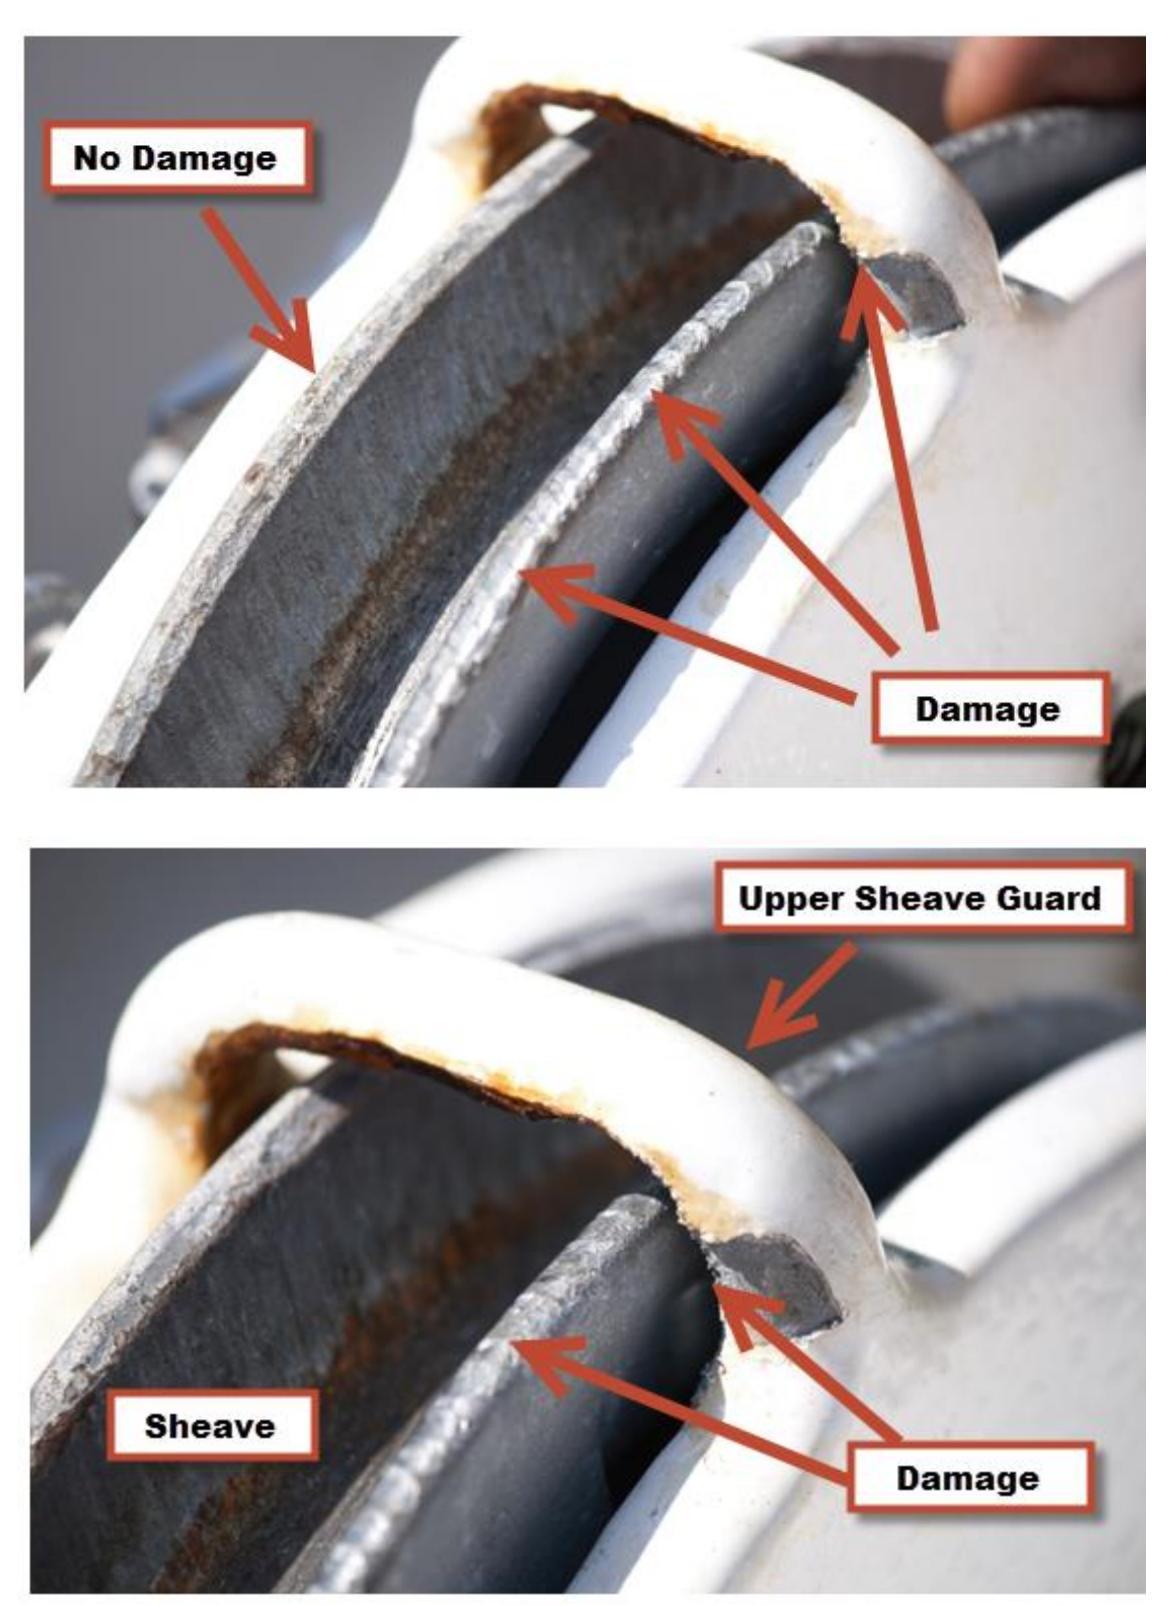
**Figure 9** – QCUM Davit *Sheave Head Assembly* images showing sheave abrasions and upper sheave guard contact.

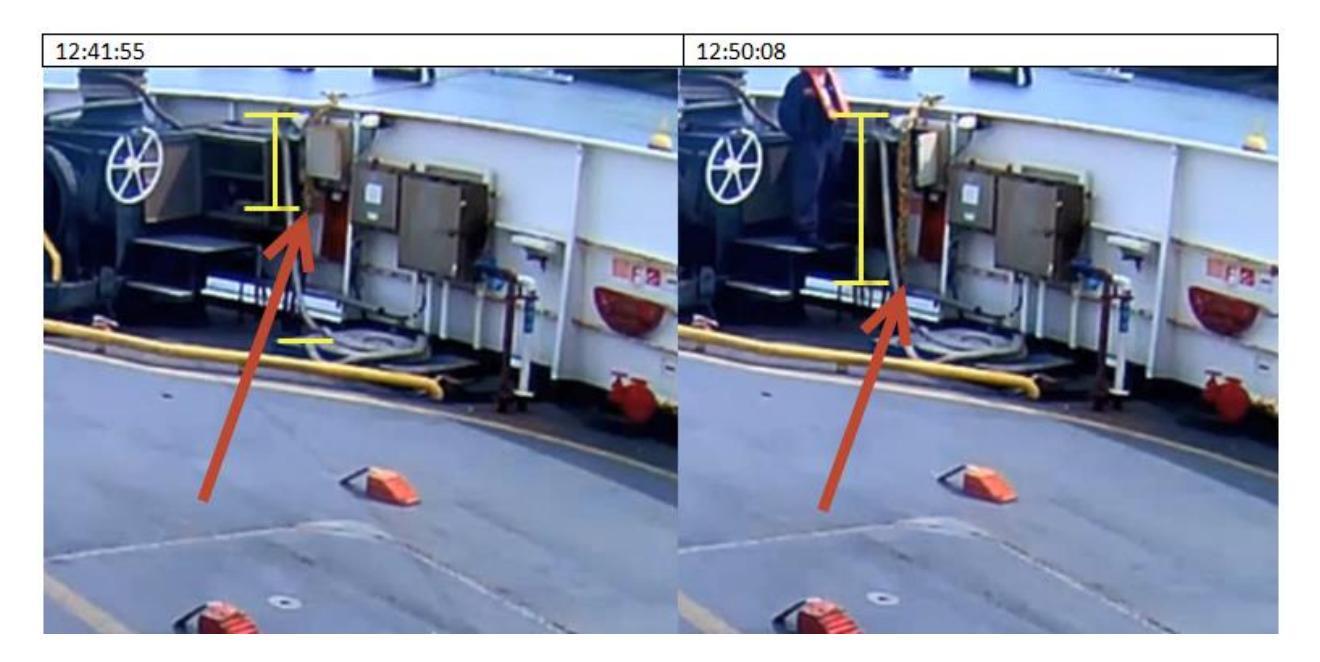
**Figure 11** – Painter length before and after the incident. Arrows indicate end of daisy chain and significant difference in length, past the cleat. (Incident occurred at 12:50:52)

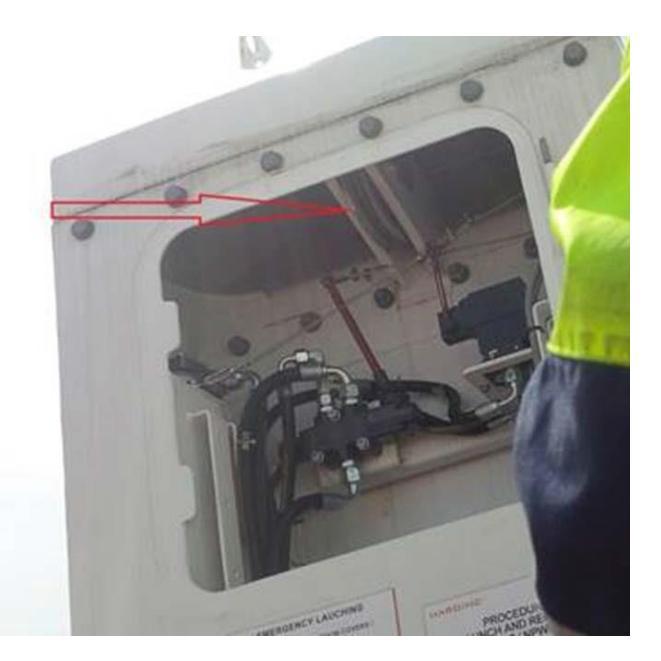
### Figure 15 Davit Casing Upper 19 April, 2018

Upper Inspection cover opened. Noted a paint chip mark on the idler sheave.

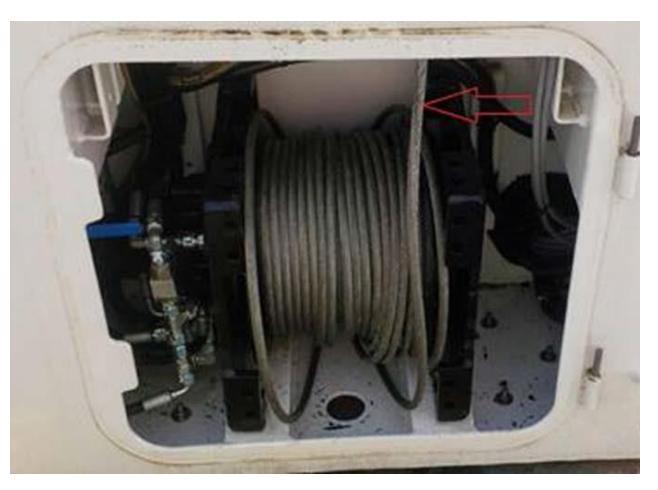
### Figure 16 Davit Casing Lower 19 April, 2018

Lower Inspection cover opened. Wire rope still on the winch drum. Noted the falls loosely coiled to right side of drum, deformed profile of wire rope across the upper length.

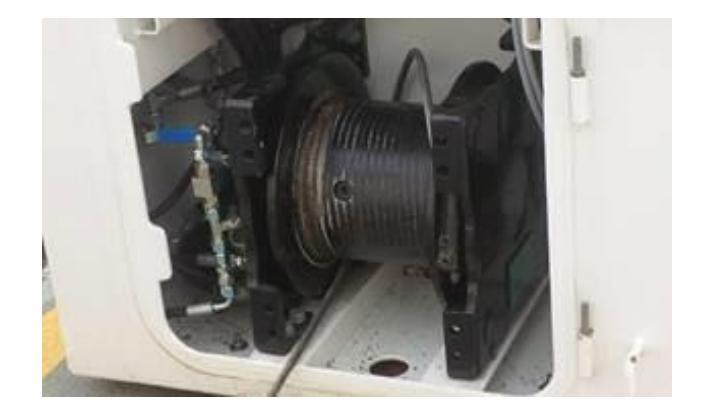
### Figure 17 Winch Drum 19 April, 2018

The drum showed normal wear.

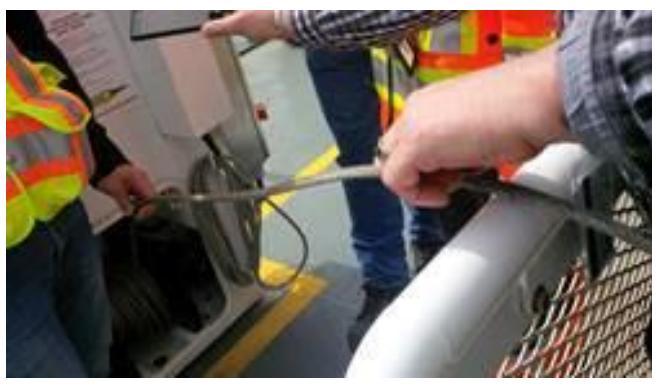
### Figure 18 Wire Rope 19 April, 2018

Inspection of wire rope (falls) along the entire length, unwound from drum and laid out on deck. 10mm rotation resistant 19x7 wire rope was in use, the chafing mark was evident to approximately 48 inches from the severed end.

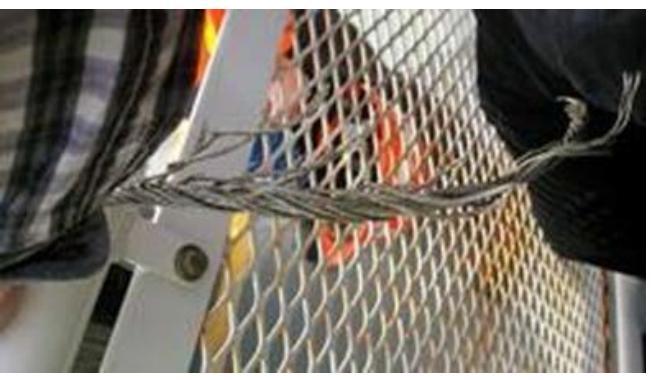
### Figure 19 Wire Rope 19 April, 2018

10mm rotation resistant 19x7 wire rope was in use, the chafing mark was evident to approximately 48 inches from the severed end.

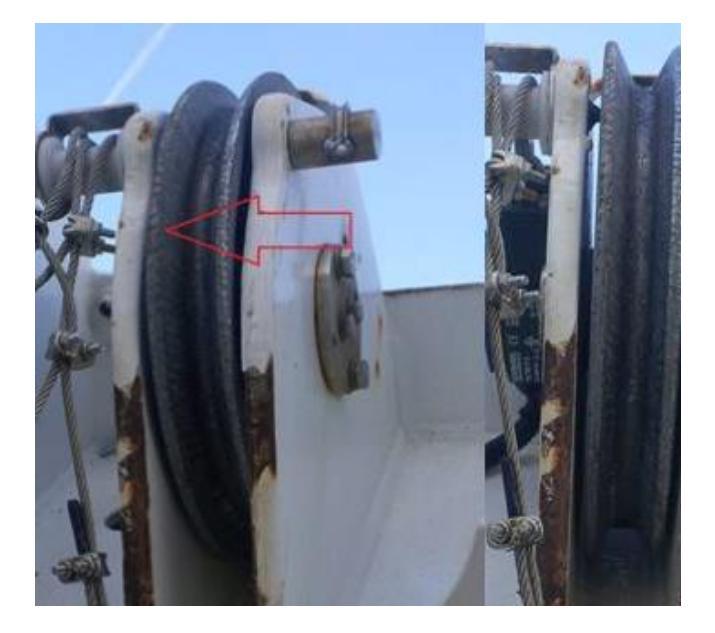
### Figure 20 Upper Sheave 19 April, 2018

Upper sheave was intact and moved freely.

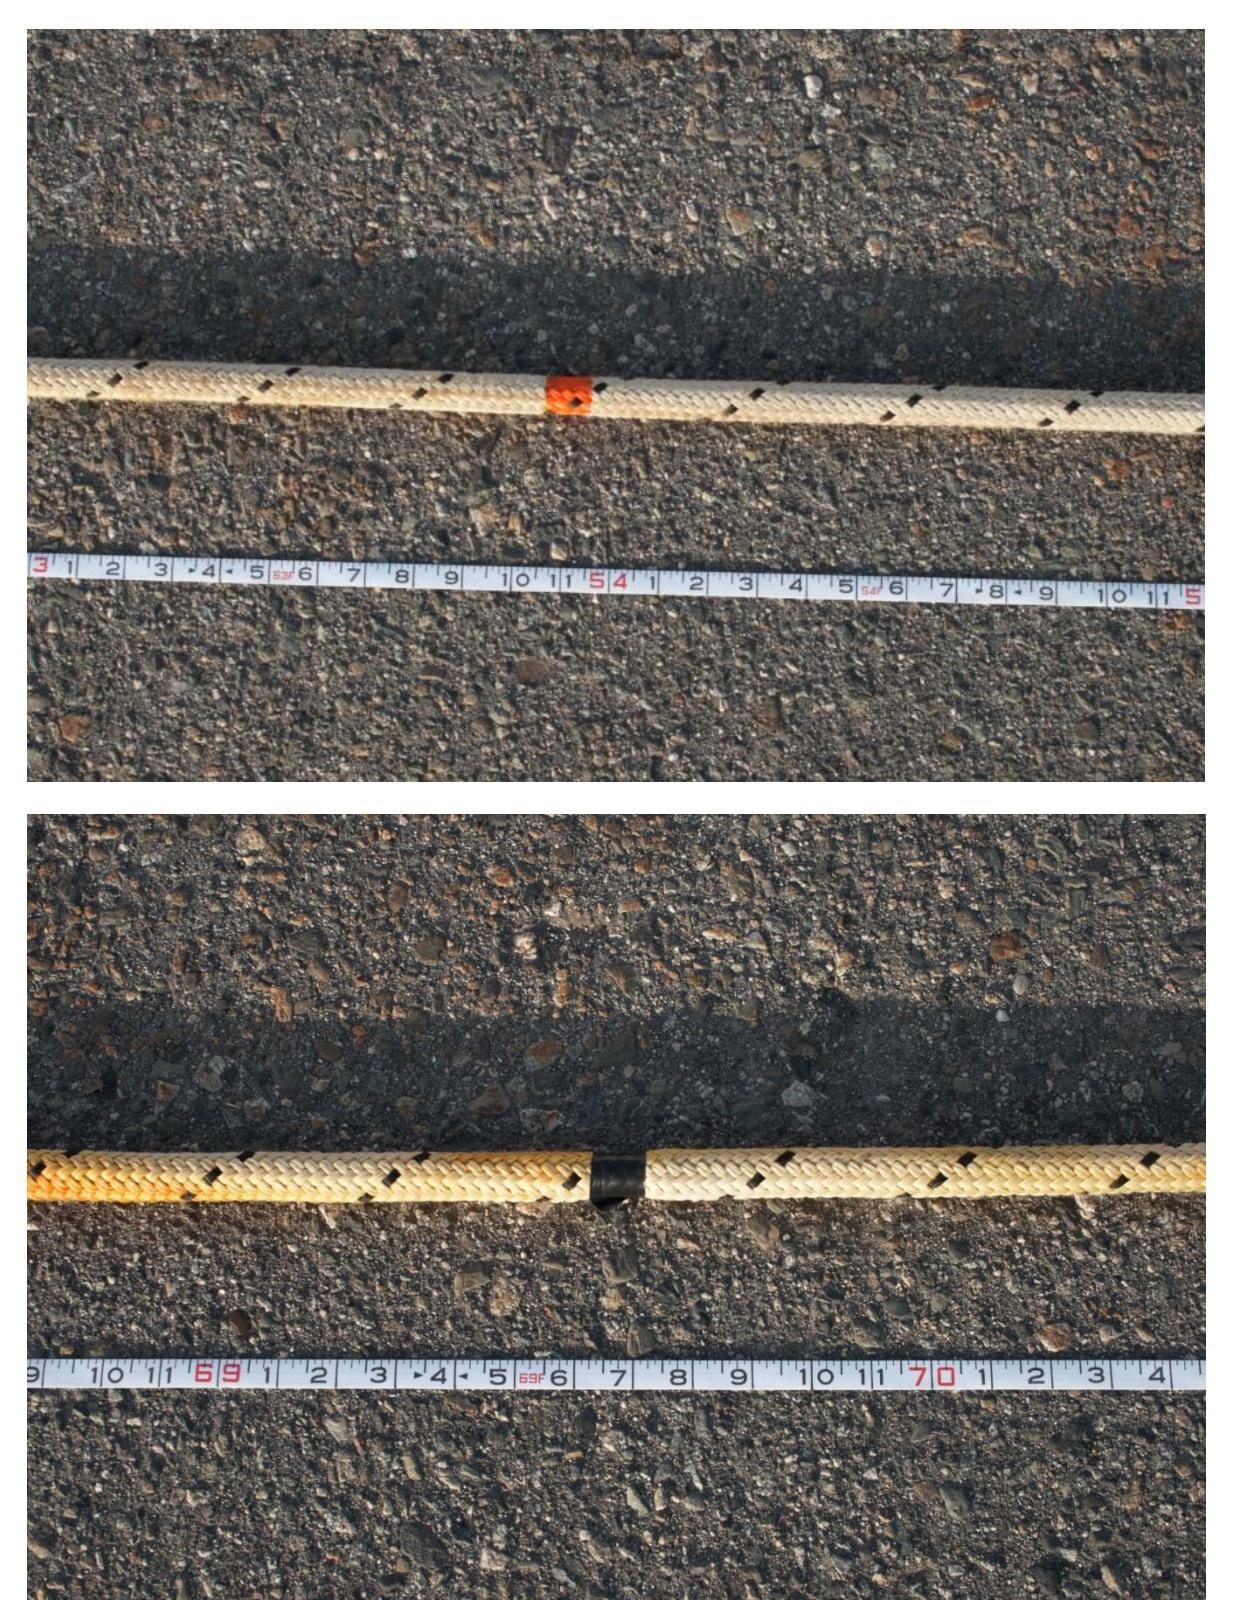
**Figure 26** – Painter markings (orange indicates less Ultra Violet damage where tape was removed – date unknown).

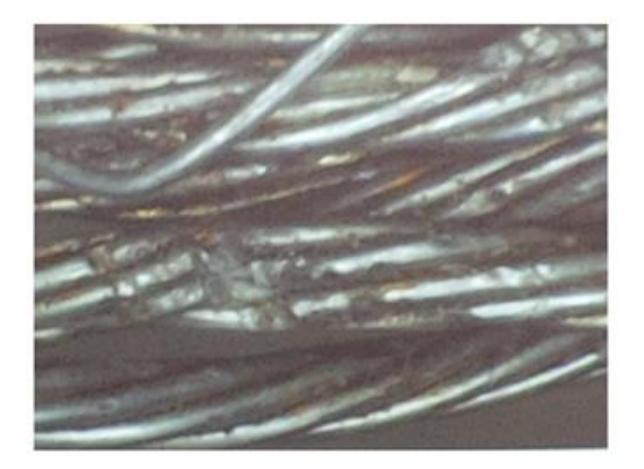
## Figure 27 – Wire rope microscopic analysis (samples)

Sufficient lubrication between wires was evident, with several marks in close proximity across a section of wires indicated crushing.

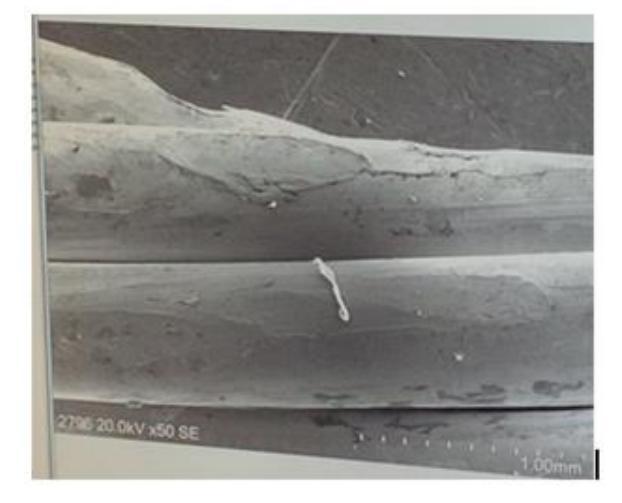
The galvanized coating of the wires was undisturbed over the majority of the surface examined – no surface corrosion noted.

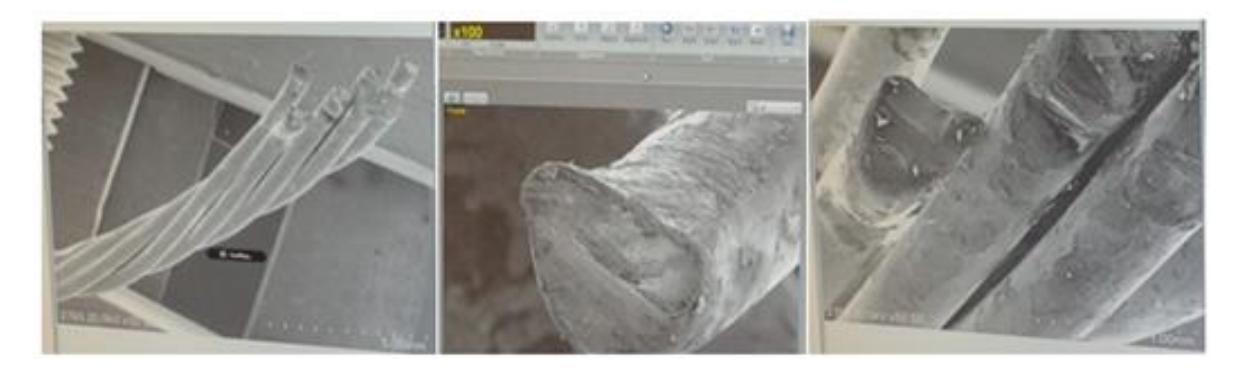
Ends had fractured (or sheared) at nearly the same length within the strand. Corrosion, fatigue or wear ruled out as probable causes. Wire was "galled" or crushed on the surface.
