# **CFerries Divisional Inquiry** DI-QCUM-10239

Incident Name:	Rescue Boat Fall During Man Overboard Drill
Worksite:	Queen of Cumberland
Location:	Swartz Bay Berth #4
Incident Date:	April 18, 2018
iSail Number:	226,156
IAR Number:	IAR-QCUM-4630

On 18 April 2018 during rescue boat drills aboard the *Queen of Cumberland* (QCUM), the davit's wire rope failed and the boat fell to the water with two employees onboard. British Columbia Ferry Services (BCFS) convened a Divisional Inquiry to investigate.

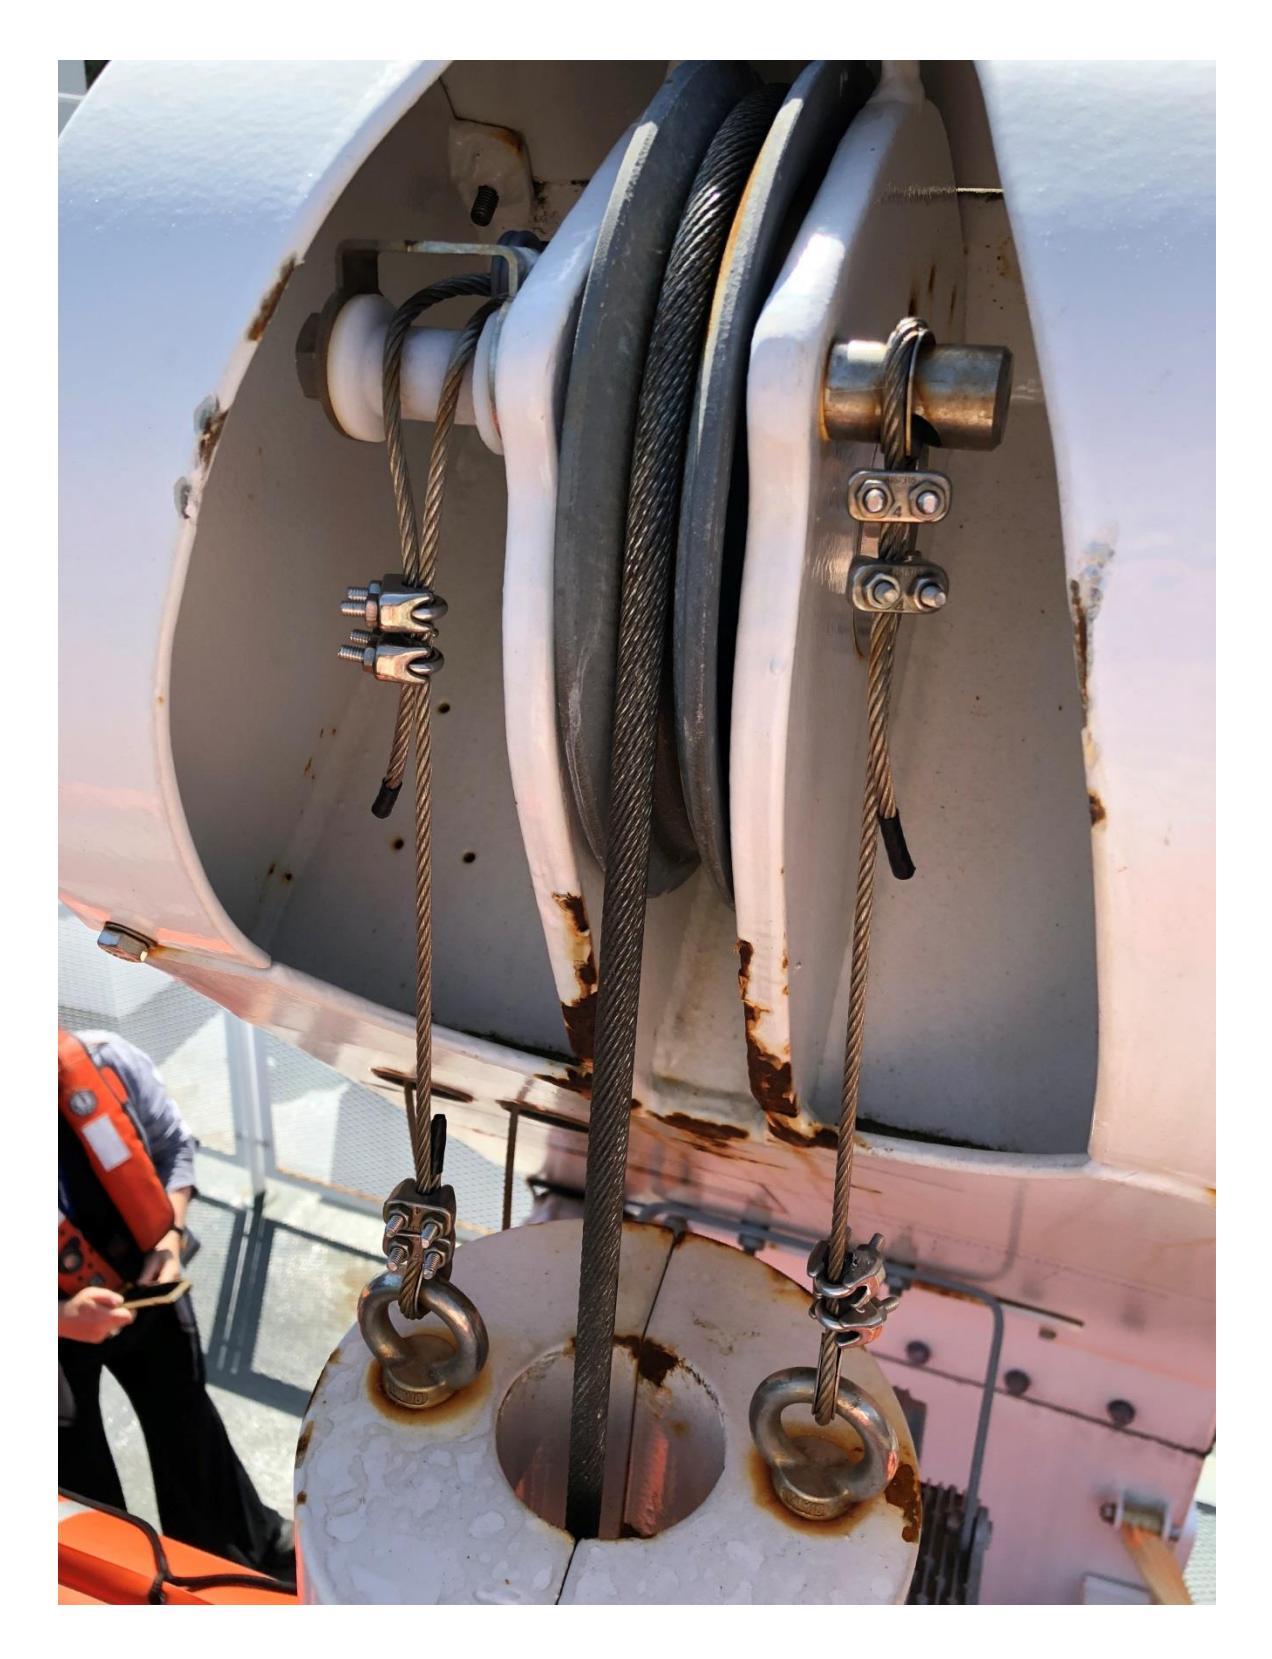
- 1. OEM Limit Switch Counterweight 20 June 2016: [Harding Service report] OEM (drastically) modifies the Limit Switch Counterweight to correct a shuddering problem when hoisting. *The service report suggests that the arrangement of the counterweight at the time of the incident (with both support wires connected to the forward side of the davit head sheave) was made at this time (Figure 5 and 6).*

Although the limit switch counterweight is not specifically designed (or specified) by the OEM to act as a wire rope falls angle limiting safety device, it was reported to have acted this way prior to the OEM technician modification in June 2016 (Figure 5 and Section 2.4 – Safety Deficiencies and Reporting).<sup>59</sup>

**Figure 5** – Image shows *Queen of Capilano* (QCAP) 1300H davit with *correct* OEM limit switch arrangement (i.e. 1 cable on either side of sheave)

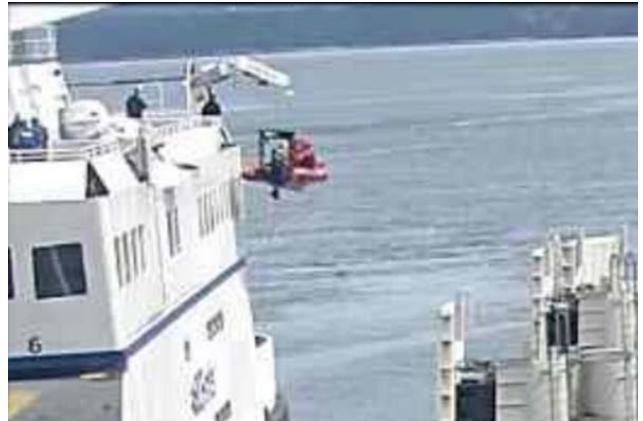
### Figure 12 Moment before Davit Failure 18 April, 2018

Closed-Circuit Television footage of QCUM at Swartz Bay Terminal. Camera view is in the direction of Berth #4 and #5. Frame captured just before the rescue boat drops.

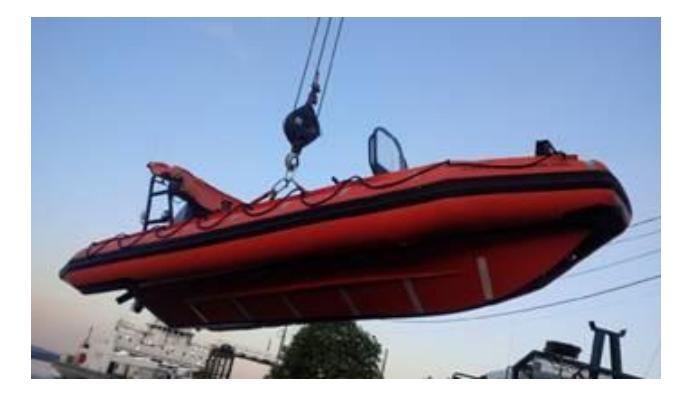
### Figure 13 Rescue Boat 18 April, 2018

Retrieved by BCFS crane truck and weighed at 635 kg on 18 April 2018.

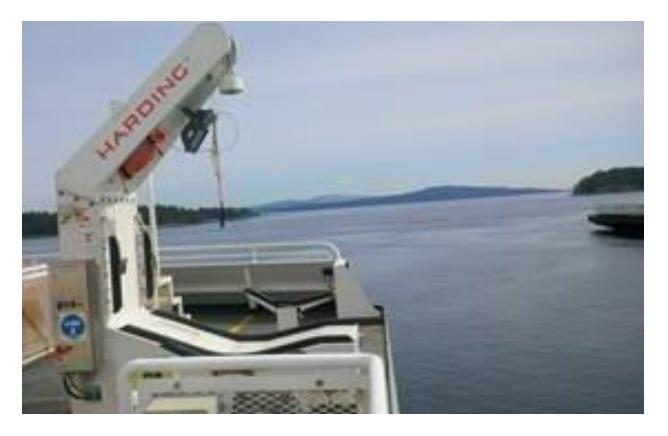
### Figure 14 Rescue Boat Davit 19 April, 2018

After lockouts had been removed, the OEM service technician pressurized the accumulator system to luff the davit inboard and back level on to the deck from the outboard position it was in at the time of failure.

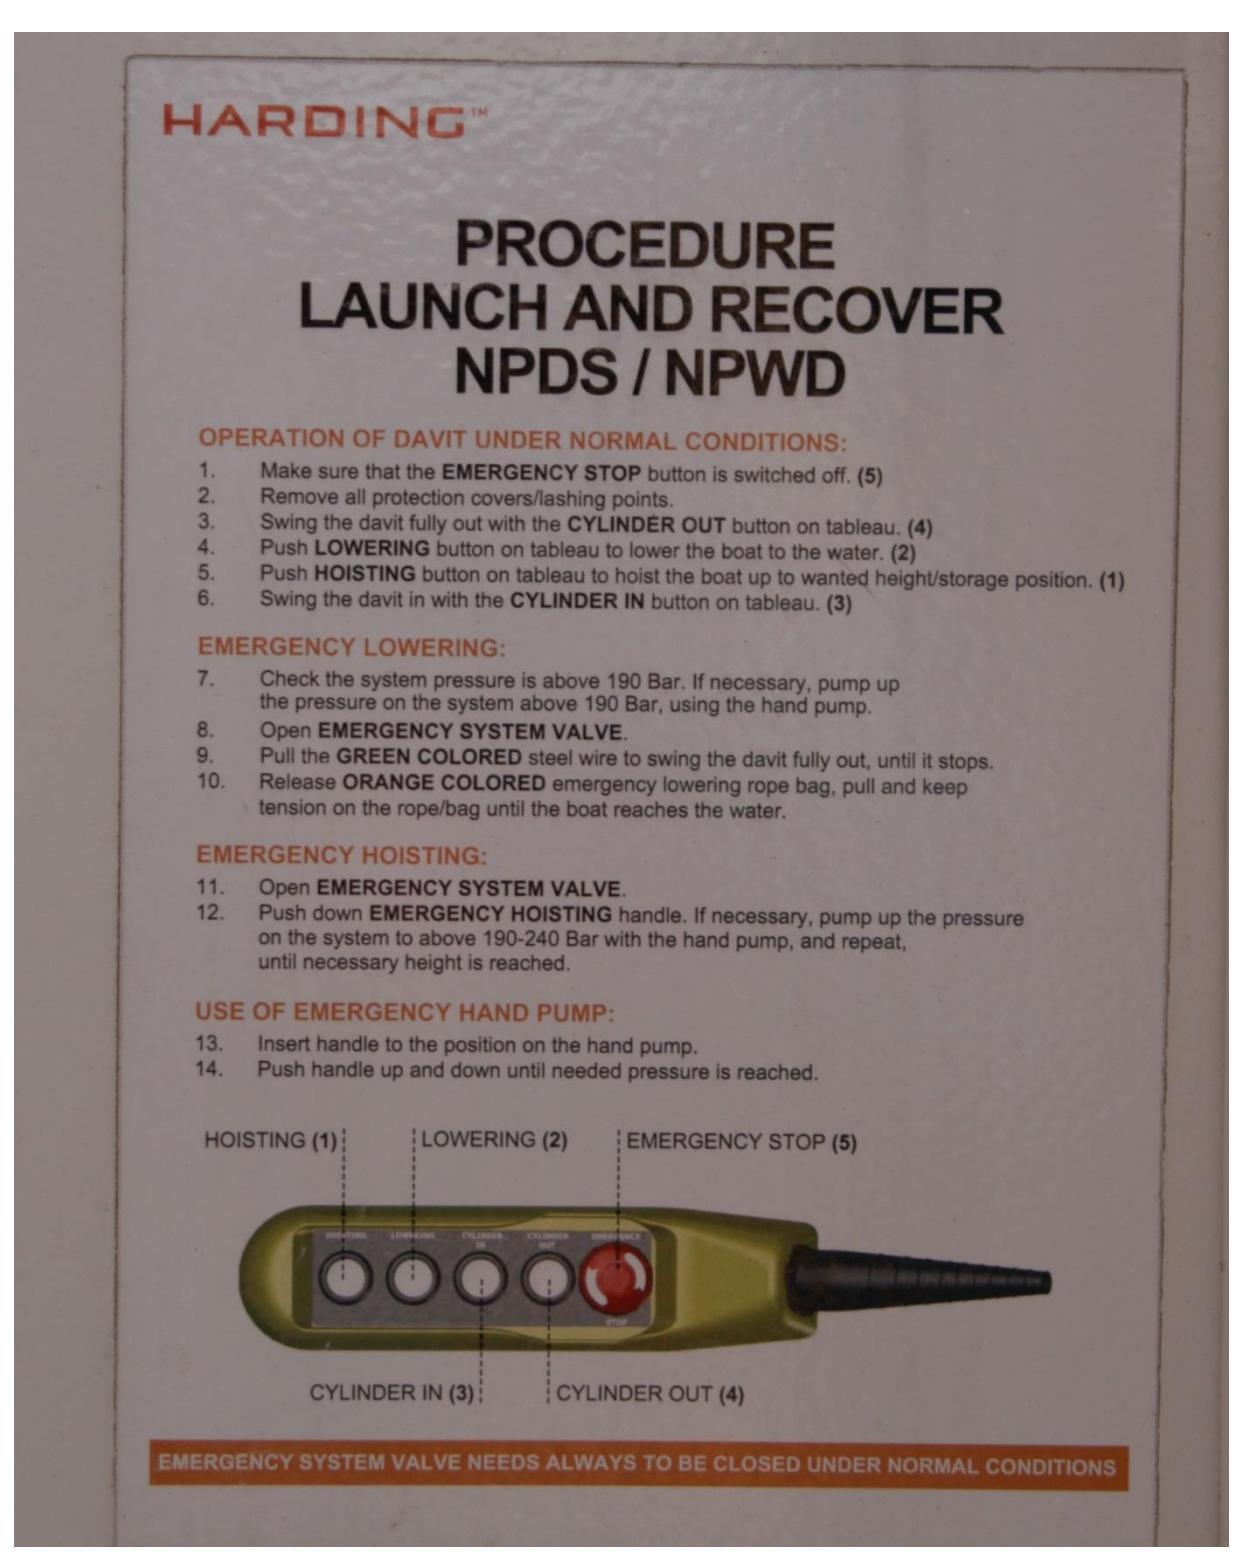
## Figure 23 – OEM procedures posted on 1300H Davit

The limit switch (and counterweight) provides over hoist protection to prevent the hook block from running into the davit head sheave (Figure 23 and 6). The LSA Code (6.1.2.7) infers no additional requirements on the function of the limit switch other than to "cut off the power before the davit arms<sup>45</sup> reach the stops in order to prevent overstressing the falls or davits."

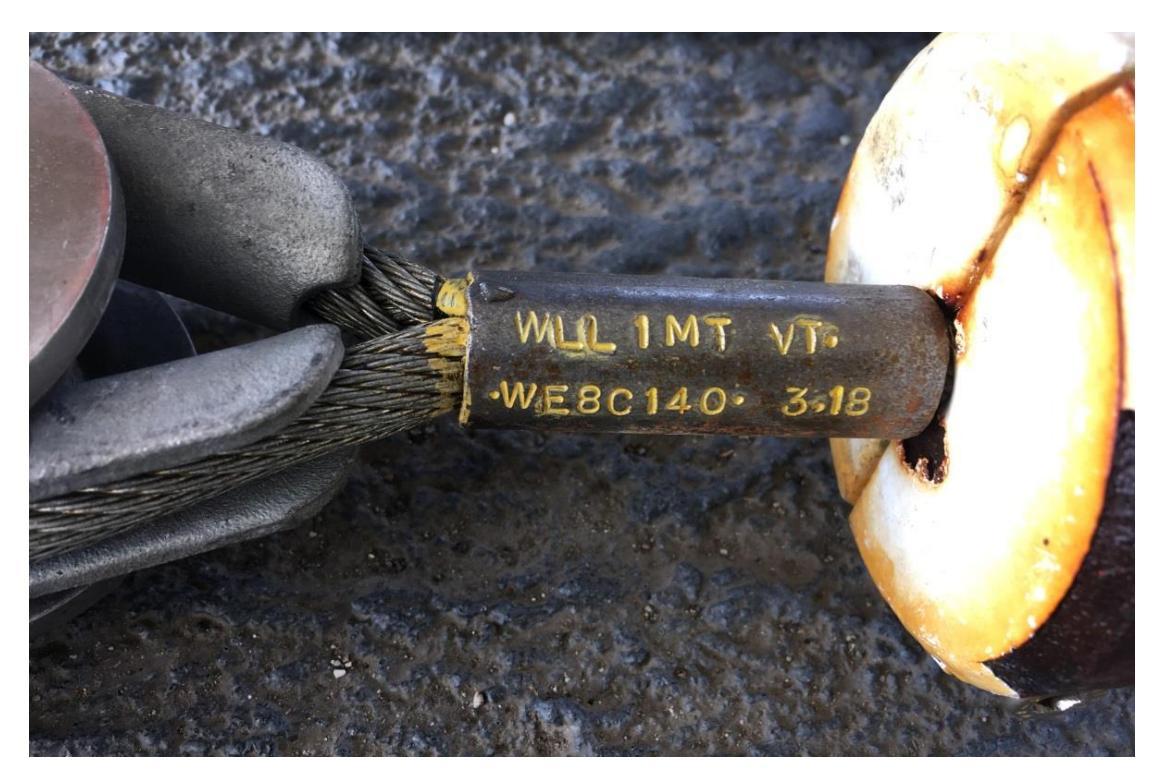
- It is inventory item 025574 and is listed on the Bill of Materials for the Job Plan "9210-QCUM-M2-8 Davit, Man Overboard, Annual".
  - $_{\odot}~$  It is given a Working Load Limit of 1000 kg (1 MT) which is stamped on the ferrule at the thimble end (Figure 29).

- The type approval certificate TC 095.060.020 for 5 m Polaris 166R/Seamaster Rescue Boat states:
  - Total weight of 1252 kg
  - A 9 person boat
- The approved Life Saving Plan for QCUM states:
  - $\circ$  A 6 person rescue boat
  - The estimated total boat weight will be 1122 kg if based on the latest LSA Code standard person weight of 82.5 kg
  - $_{\odot}$  The boat weight is greater than the 1000 kg (1MT) Working Load Limit  $^{60}$  stamped on the wire rope falls ferrule (Figure 29)

Figure 28 – QCUM wire rope falls *ferrule*

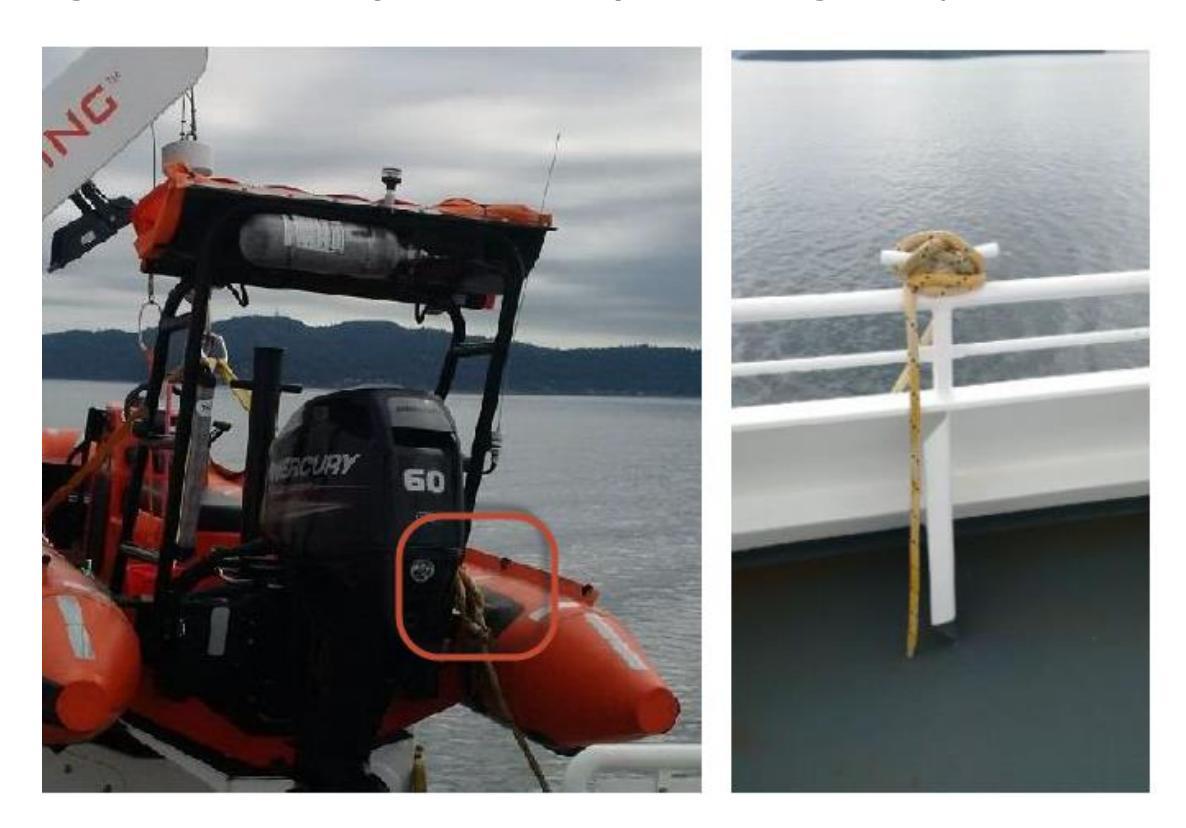
**Figure 29 –** *Previous* **QCUM R/B stern painter arrangement** (*with Sun Deck cleat*)
